RESEARCH MEMORANDUM

INFLUENCE OF BORIC OXIDE DEPOSITION ON TURBOJET-
ENGINE OPERATION

By James W. Useller, Richard R. Burley, and
Wallace W. Velie

Lewis Flight Propulsion Laboratory
Cleveland, Ohio

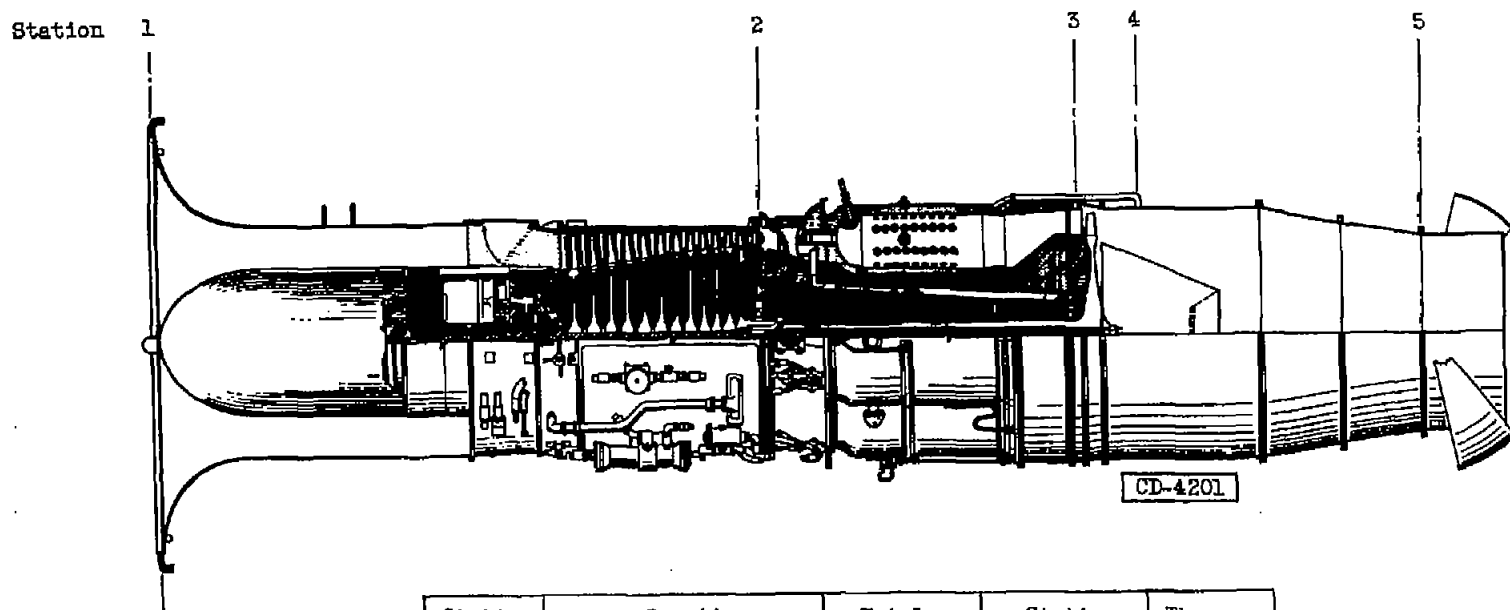
Station	Location	Total-pressure probes	Static-pressure probes	Thermo-couples
0	Inlet air measuring station	9	7	4
1	Engine inlet	-	-	20
2	Compressor outlet	10	4	10
3	Turbine inlet	12	-	30
4	Turbine outlet	7	-	20
5	Exhaust-nozzle inlet	12	-	14

Figure 1. - Schematic diagram of turbojet engine showing location of pressure and temperature instrumentation used throughout engine.

Engine and installation. - The turbojet engine used in this investigation was a standard production model with a nominal thrust rating of 5920 pounds at a rotational speed of 7950 rpm and a turbine-discharge gas temperature of 1275° F. A schematic diagram of the engine is shown in figure 1. The following modifications were made to the engine for operation with the trimethyl borate fuel:

Instrumentation. - The number and location of the total- and static-pressure and temperature instrumentation used in this investigation are tabulated in figure 1. Pressure instrumentation used downstream of the combustor outlet was of the air-purging type to exclude collection of boric oxide and subsequent blockage. A sketch of a typical purging-type pressure probe is shown in figure 3.

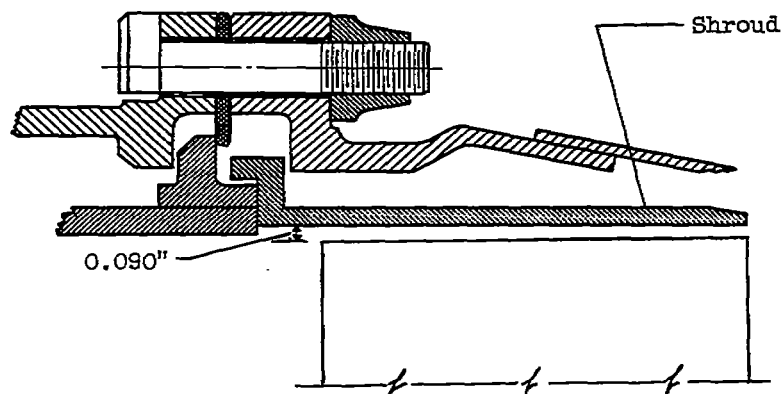
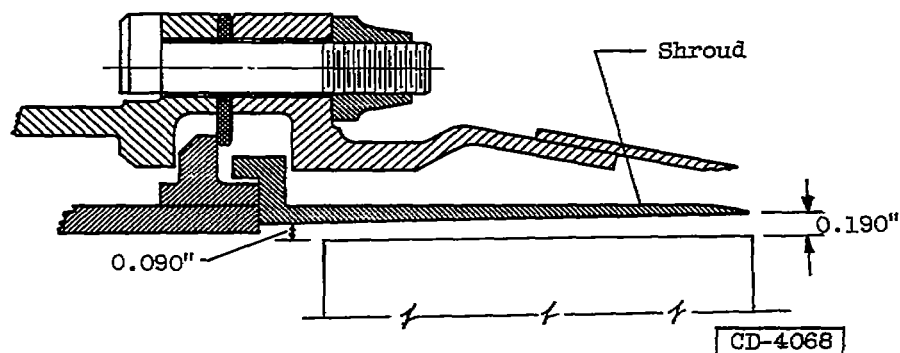
Standard turbine shroud

Modified turbine shroud

(a) Turbine-clearance increase.

Figure 2. - Modifications to standard turbojet-engine components for operation with trimethyl borate fuel.

^aSee fig. 2(a).

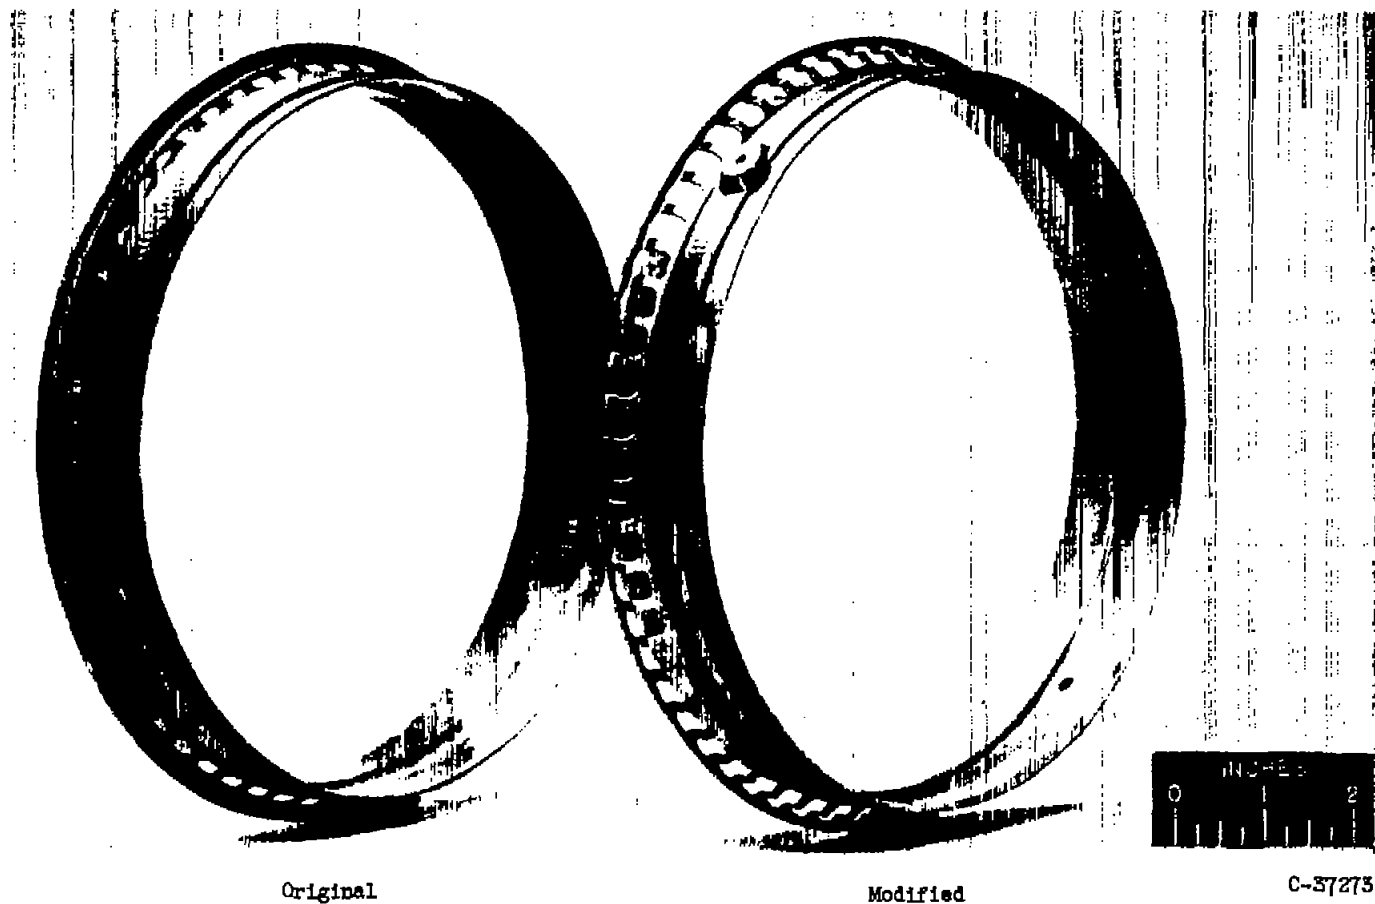
(b) Combustor-outlet retainer-ring modification.

Figure 2. - Concluded. Modifications to standard turbojet-engine components for operation with trimethyl borate fuel.

^bSee fig. 2(b).

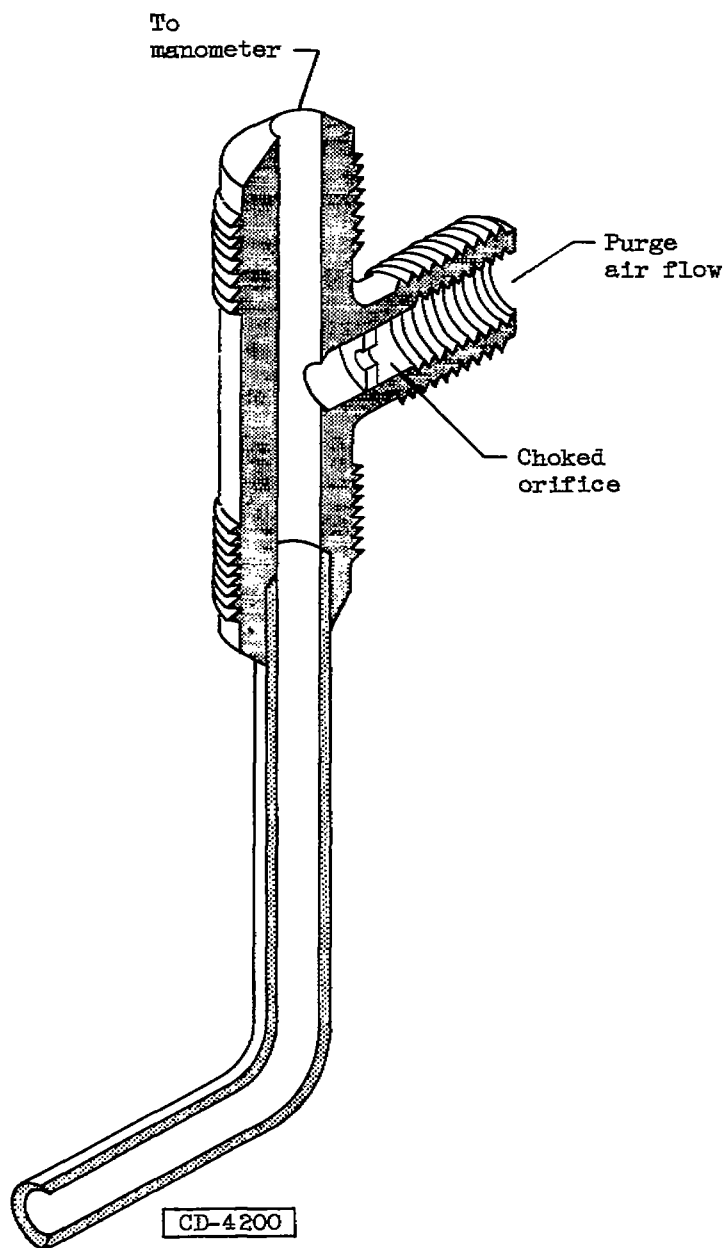
Figure 3. - Purge-type pressure instrumentation used downstream of combustor to prevent boric oxide interference.

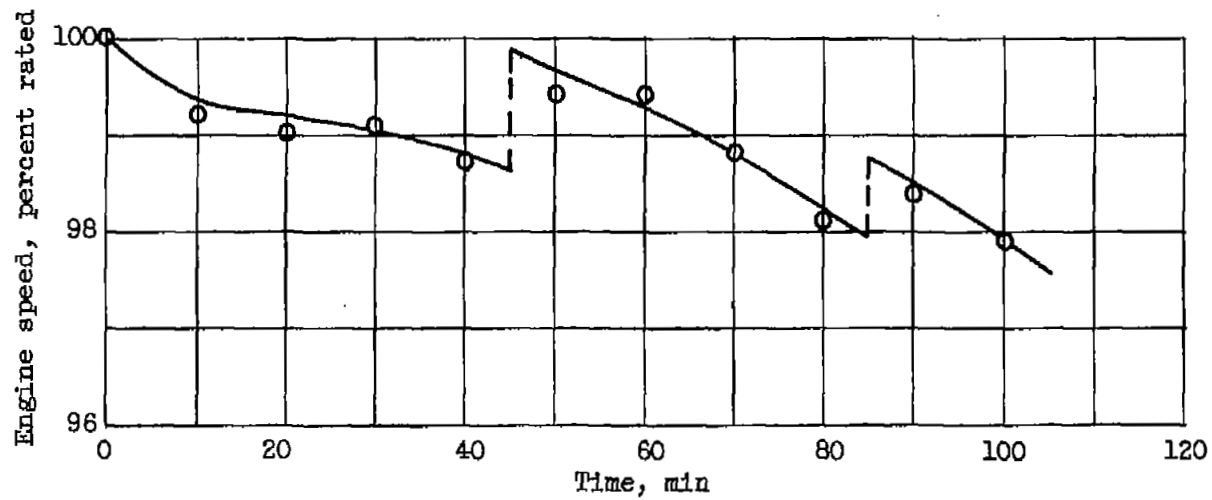
Figure 6. - Effect of boric oxide deposition on turbojet-engine speed.
Configuration A. Tail-pipe temperature, 1700° R.

Engine operation and performance. - The engine fuel flow and exhaust-nozzle area were maintained constant and the engine speed was permitted to decrease so as to maintain a tail-pipe temperature of 1700° R. A maximum engine speed decrease of 2 percent was measured using configuration A as is shown in figure 6. The decrease in engine speed resulted from the increased combustor pressure drop and the burning of some of the fuel downstream of the turbine as may be seen from figure 7. Operation was for 100 minutes with trimethyl borate fuel. The irregular changes in engine speed that occurred at 45 and 85 minutes are believed to have resulted from the dislodgment of sizeable quantities of the accumulated deposits of the combustor.

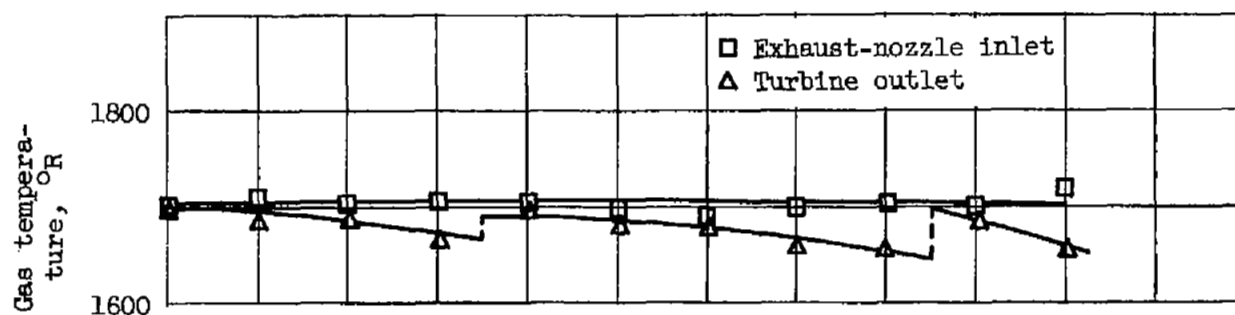
(a) Turbine-outlet and exhaust-gas temperatures.

Figure 7. - Effect of boric oxide deposition on turbojet-engine temperatures and pressures. Configuration A. Tail-pipe temperature, 1700° R.

It may be seen in figure 7(a) that the turbine-discharge gas temperature decreased with time (increasing deposition) while the gas temperature measured downstream (at the exhaust-nozzle inlet) remained constant.

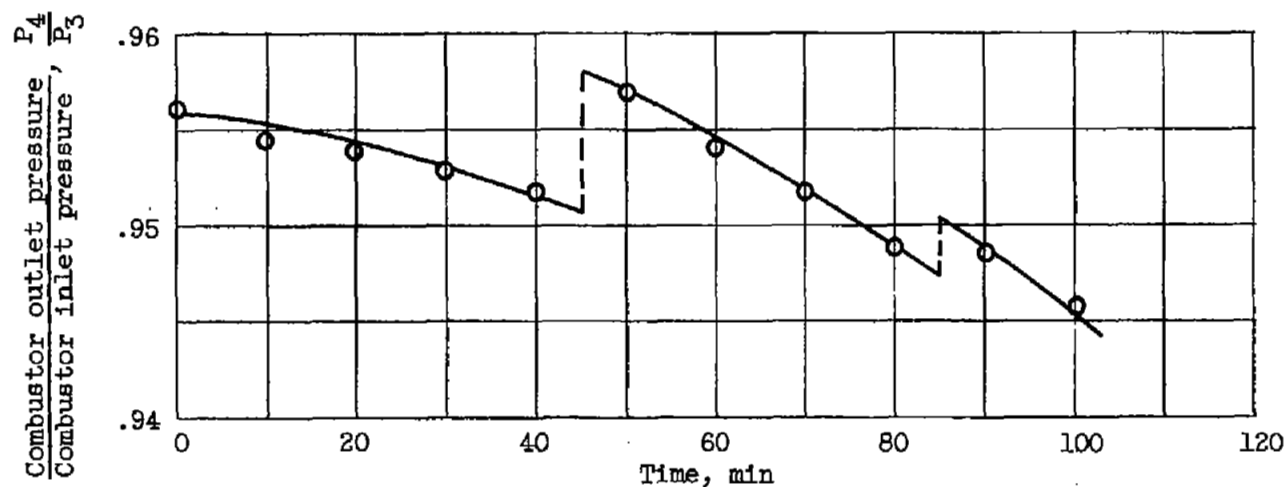
(b) Combustor total-pressure ratio.

The effect of the boric oxide deposits that accumulated in the combustion chambers (shown in photographs of fig. 5) was to increase the total-pressure loss in the combustor. Following 100 minutes of operation with the trimethyl borate fuel, the combustor total-pressure ratio (outlet to inlet) decreased from 95.6 to 94.6 percent (fig. 7(b)).

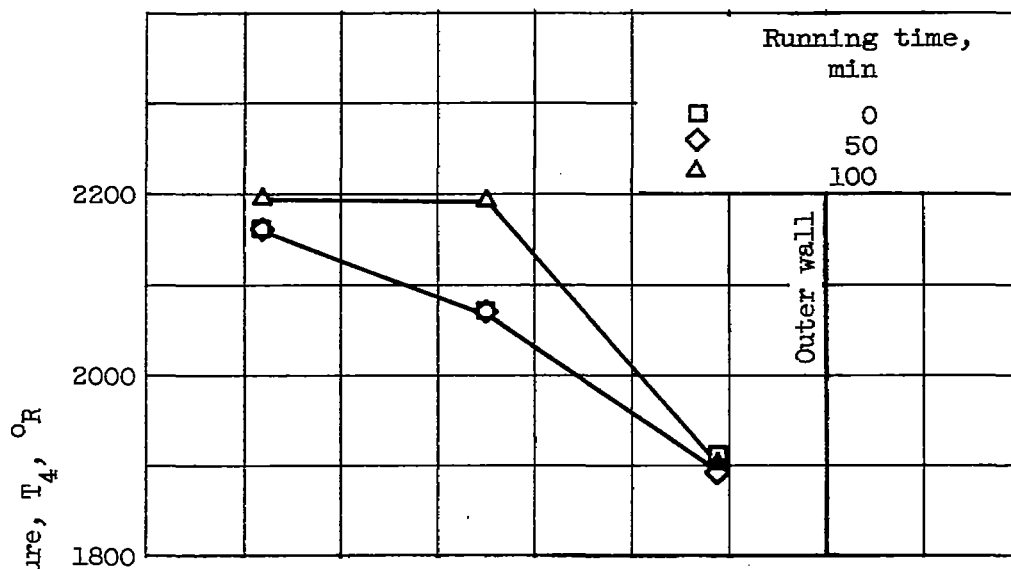
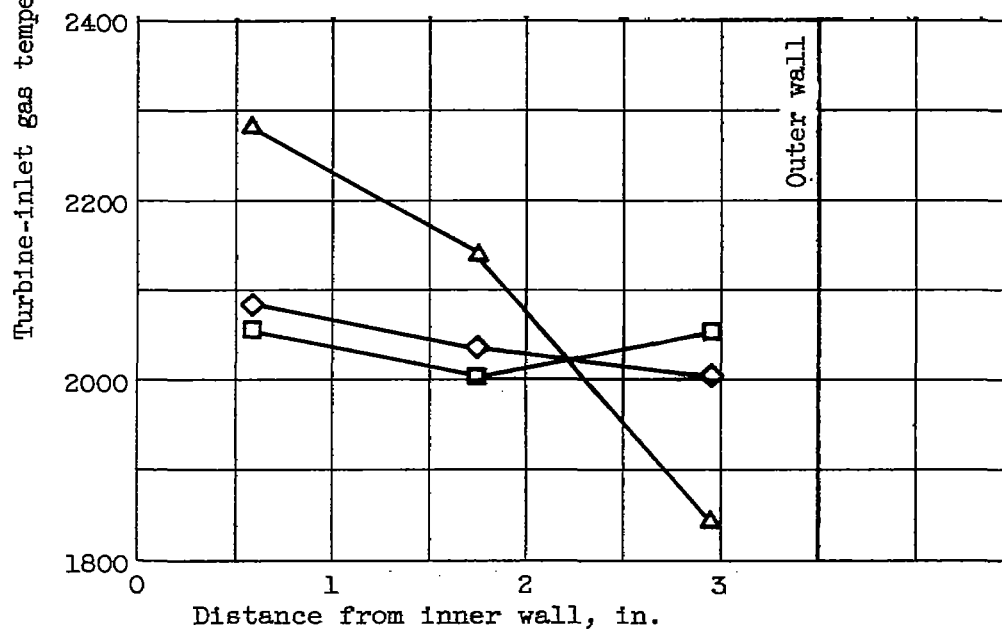
(a) Downstream of combustor 1.

(b) Between combustors 1 and 2.

Figure 8. - Change in turbine-inlet gas-temperature profiles with operation of engine with trimethyl borate fuel.

at the turbine. Figure 8 shows the variation of the turbine-inlet gas-temperature profile at several time intervals during operation with trimethyl borate. Radial profiles are shown for positions at the turbine inlet both behind a combustor and between two combustors. In general, a somewhat steeper temperature gradient from the inner portion of the annulus to the outer wall was experienced with prolonged use of the trimethyl borate. The change in turbine-inlet total-pressure profile is shown in figure 9. Both the circumferential pressure distribution (fig. 9(a)) and the radial pressure profile (fig. 9(b)) were slightly altered because of the accumulated boric oxide deposits in the combustor.

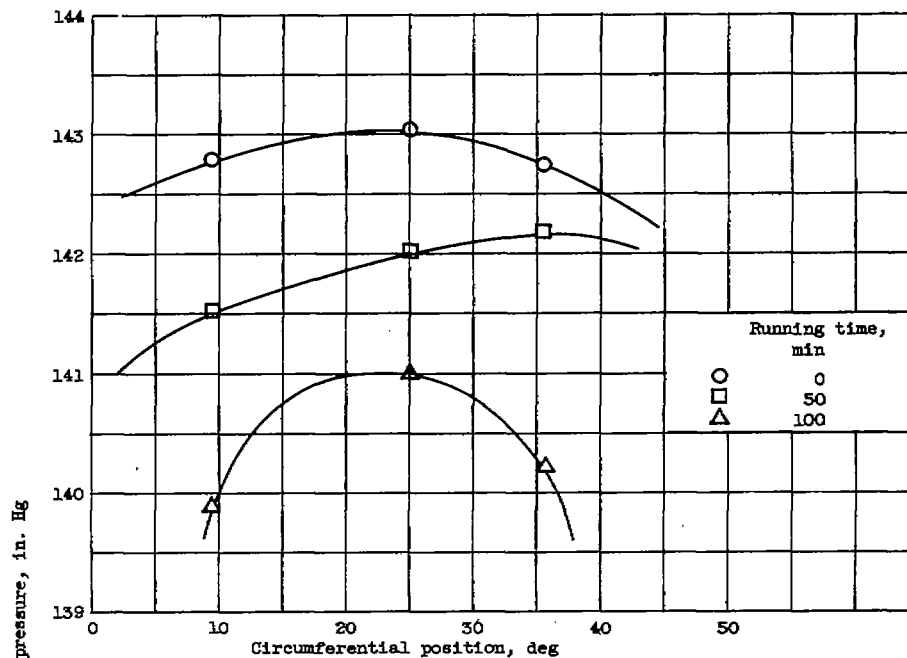
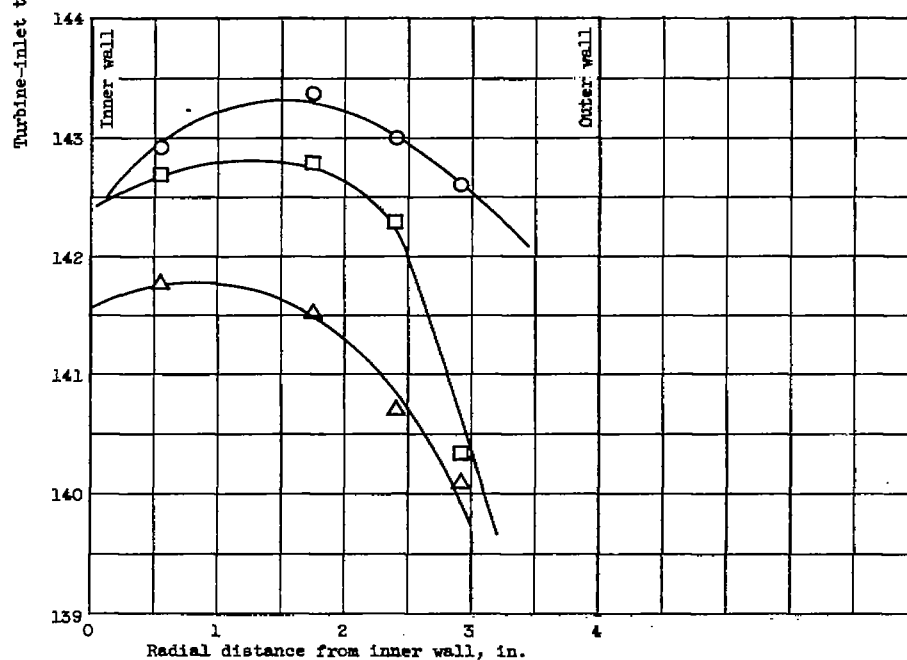
(a) Circumferential pressure distribution.

(b) Radial pressure profile.

Figure 9. - Change in turbine-inlet total-pressure profiles with operation of engine with trimethyl borate fuel.

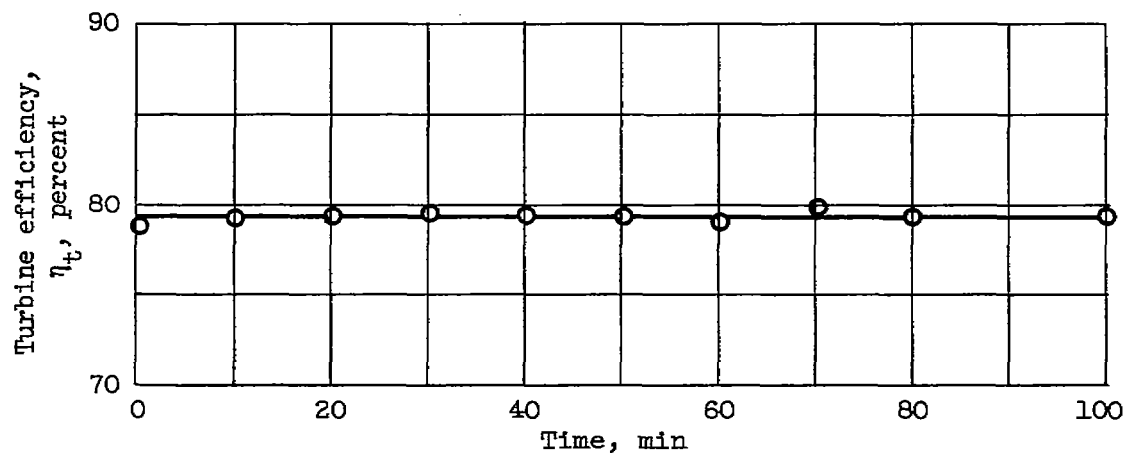
Figure 10. - Effect of operation of turbojet engine with trimethyl borate fuel on turbine efficiency. Tail-pipe temperature, 1700° R.

Although the combustor deposits altered the temperature and pressure distributions entering the turbine nozzle diaphragm, these relatively small changes were insufficient to produce a measurable change in the performance of the turbine. The turbine efficiency (fig. 10) remained constant throughout the investigation even with prolonged use of the trimethyl borate fuel.

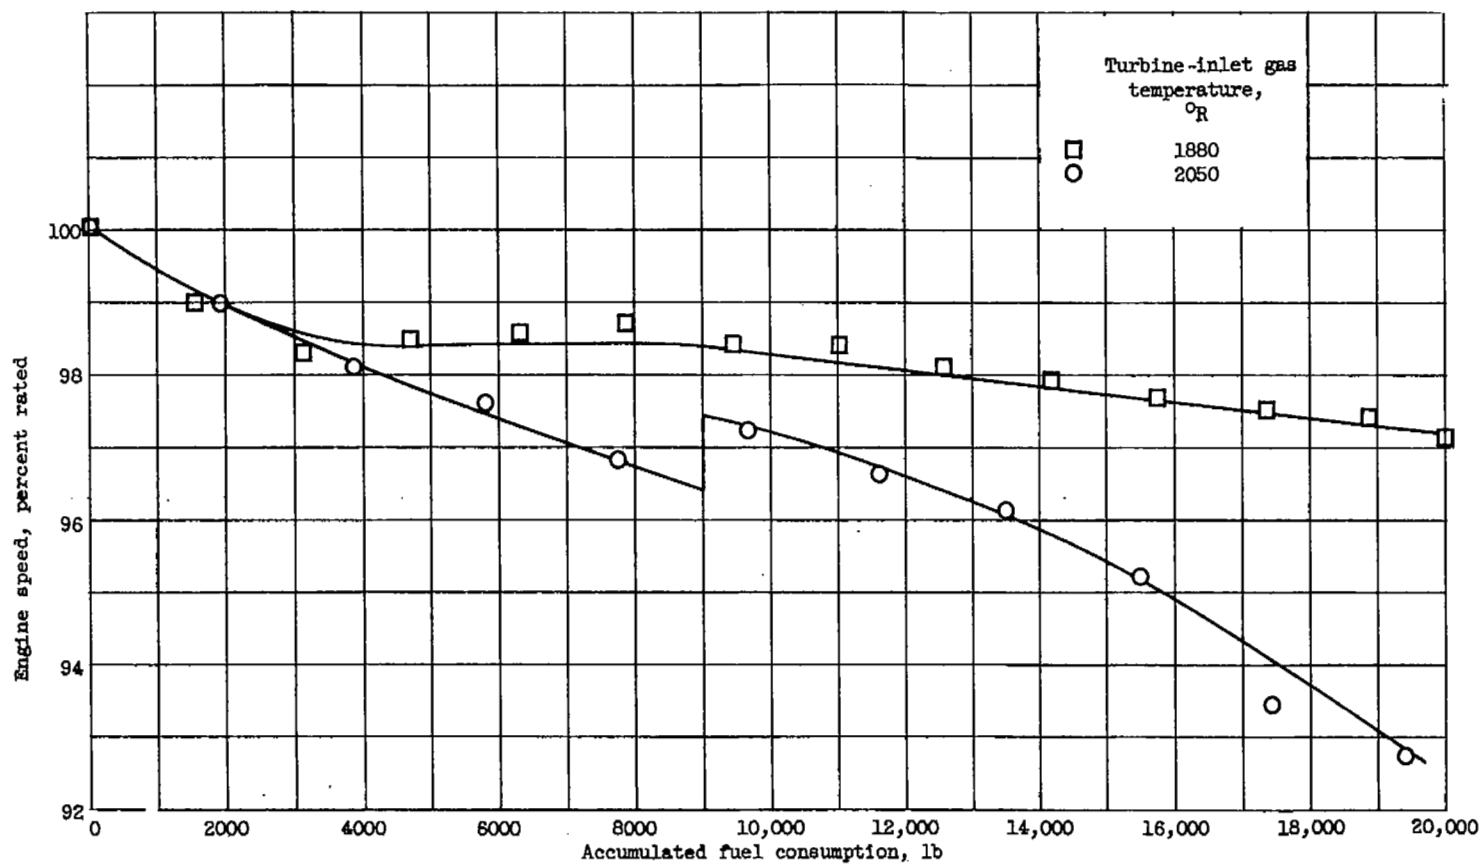
Figure 11. - Effect of turbine-inlet temperature on engine speed deterioration during operation with trimethyl borate fuel. Configuration B.

With a turbine-inlet gas temperature of 1880° R, the oxide deposits caused a 2.8-percent reduction in engine speed. Increasing the turbine-inlet temperature from 1880° to 2050° R caused an engine speed deterioration of approximately 7.3 percent for a similar quantity of fuel consumption. The comparison of engine speed deterioration is presented in figure 11 as a function of the accumulated fuel consumption because the oxide formation is a direct function of the fuel-consumption rate. The tendency to increase the oxide deposition and consequently cause a further speed deterioration with increased turbine-inlet temperature is contrary to expectation. It was anticipated that the erosion would increase with the reduced viscosity of the deposits at higher temperatures. The increased oxide-deposition trend, however, has been substantiated with unpublished data obtained on a single combustor rig. It is believed that this incongruity can be explained by the fact that the

The irregularity of the data shown in figure 11 for 2050° R turbine-inlet temperature for fuel consumption between 8000 and 10,000 pounds is again believed due to a sudden change in the deposits such as would occur with the dislodgment of large pieces.

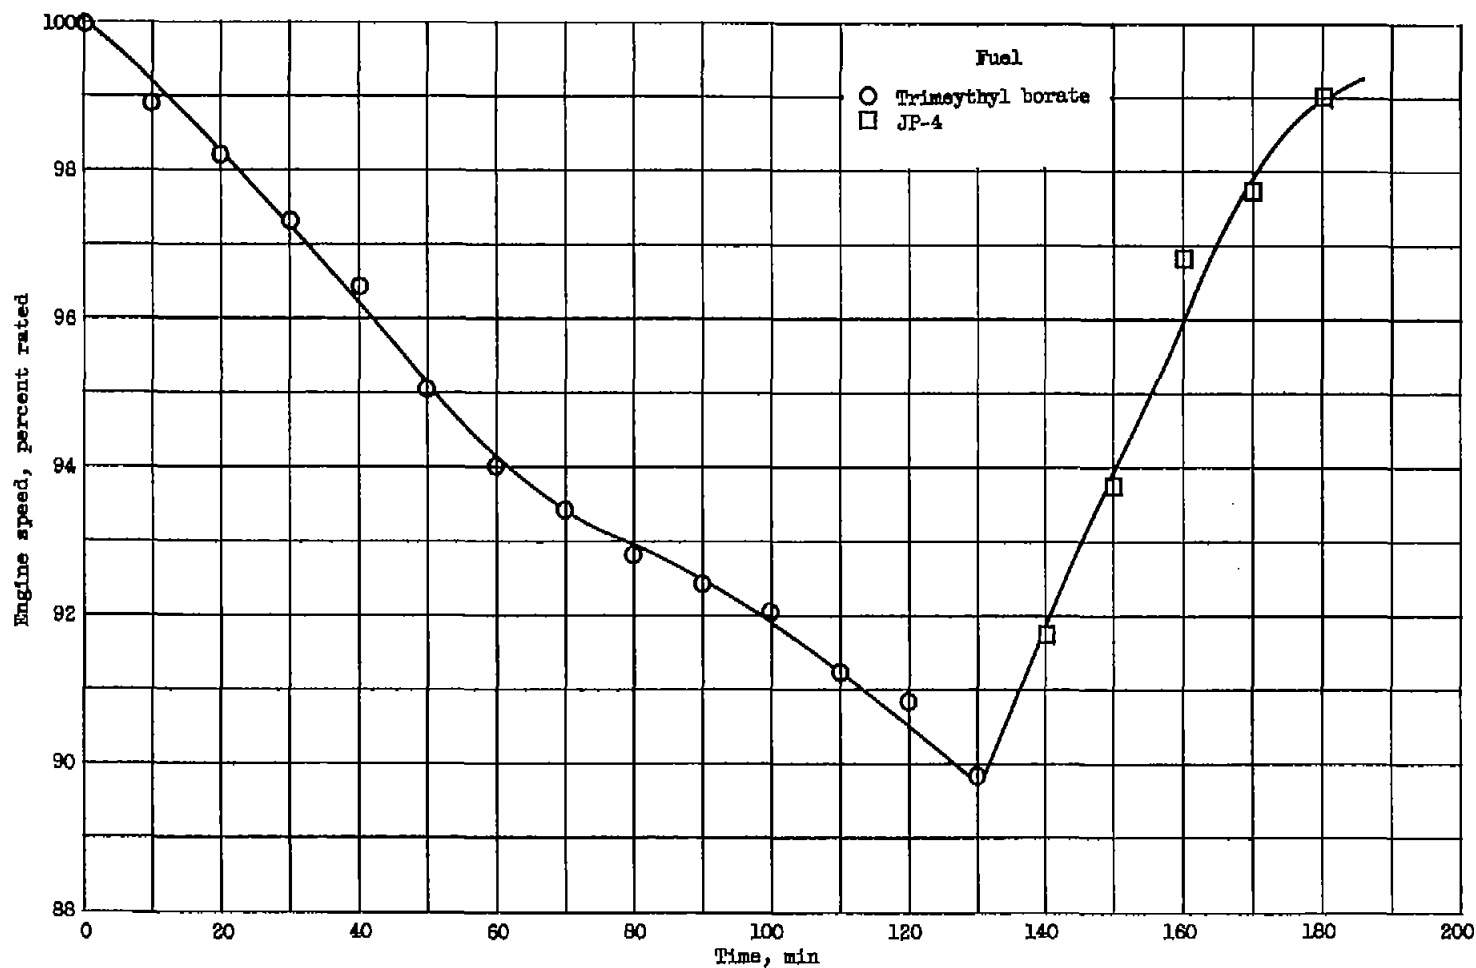
Figure 12. - Dissipation of effect of boric oxide deposits in engine components by operation with JP-4 fuel. Rated engine conditions. Static sea-level operation. Tail-pipe temperature, 1700° R. Configuration C.

Subsequent to the operation with trimethyl borate, the engine was operated with hydrocarbon fuel, JP-4. After about 50 minutes of operation with JP-4, the engine speed approached normal operation, as is shown in figure 12, indicating substantial removal of the deposits. Visual inspection showed that the deposits throughout the engine were dissipated by the JP-4 operation. Figure 13(a) shows the deposits in a typical combustor following operation with JP-4 fuel, and figure 13(b) shows the relatively minor deposits remaining in the engine tail pipe.
